PROPERTY CONDITION ASSESSMENT

1234 Business Town
Businessland, CA 12345

Prepared for:
Commercial Client

Prepared by:
CalPro Inspection Group
3565 Taylor Rd, Suite D
Loomis, CA 95650
800-474-3540

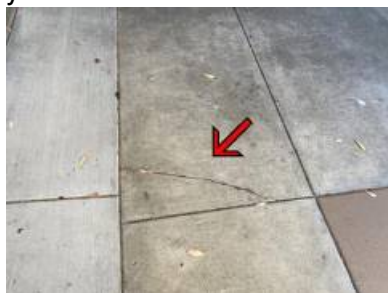
All walkways on the site are paved with concrete. Good condition. Typical settling cracks were noted. All concrete, asphalt and masonry surfaces eventually crack, (it's just a matter of degree), and the cracks observed appear to be normal. The life expectancy of driveway and sidewalk paving is about 40 to 50 years.

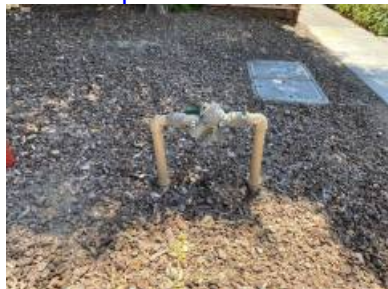
The water shutoff and meter are located in an underground vault on the west side of the property. **No protection is installed to prevent vehicle collision. We recommend pipe bollards be installed to prevent vehicles from colliding into water pipes. The back flow preventer is leaking and needs assessment by a licensed plumber.**

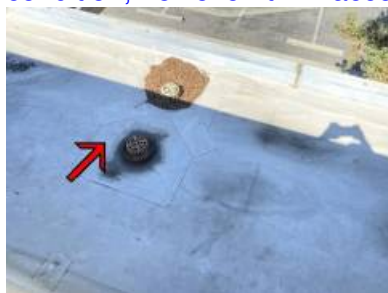
Roof drainage is accomplished by drains and overflows built into the roofing surface, as typical for a low pitch roof. All gutters and drains appear to be in acceptable condition. Debris (from overhanging vegetation, mineral deposits from roof shingles, etc.) were noted in the gutters, this is a common condition, however it will accelerate deterioration of gutters. Regular maintenance is needed.

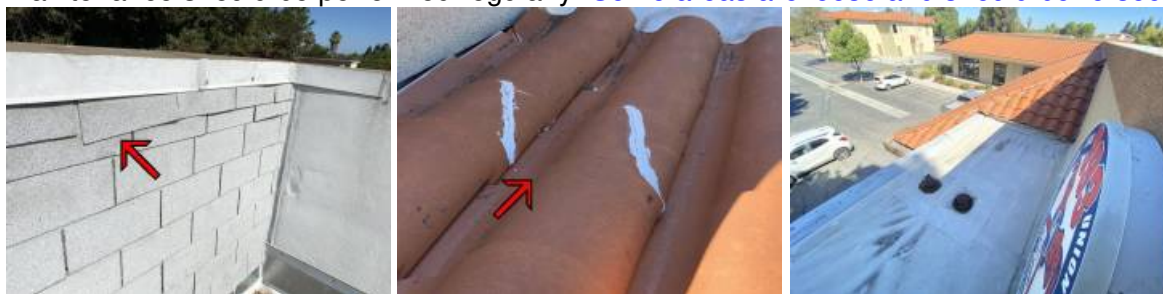
Roofing application consists of concrete tile. Typical life expectancy of a concrete tile roof is 35 to 50 years, assuming that broken tile are replaced and the roof is maintained. The wall covering at these locations is Composition Shingles. Typical life expectancy of a 3-tab composition roof is 15 to 18 years, assuming that the roof is properly maintained. Previous repairs made to roof tiles. Repair & replacement maintenance should be performed regularly. **Some areas are loose and should be re-secured.**

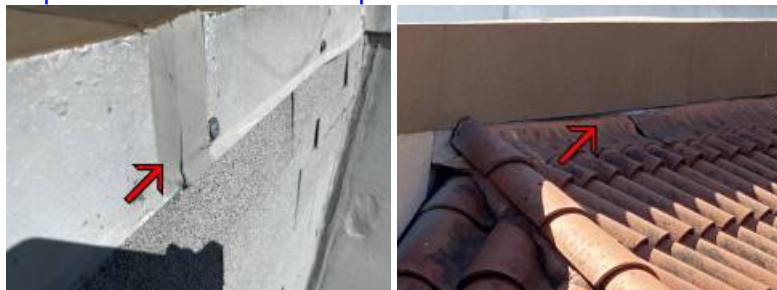
Roof flashings appear to be adequately installed and maintained. **Flashing sealant in some locations is cracked and needs re-sealing to prevent water intrusion. Lead flashing is loose/disturbed in some areas. Repair is recommended to prevent water intrusion.**

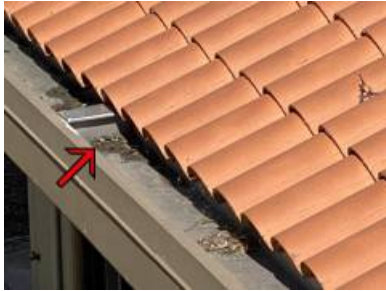
Roof drainage is accomplished by means of galvanized metal gutters installed at the low end of the sloped roofs. All gutters and drains appear to be in acceptable condition. **Debris (from overhanging vegetation, mineral deposits from roof shingles, etc.) were noted in the gutters, this is a common condition, however it will accelerate deterioration of gutters. Regular maintenance is needed.**

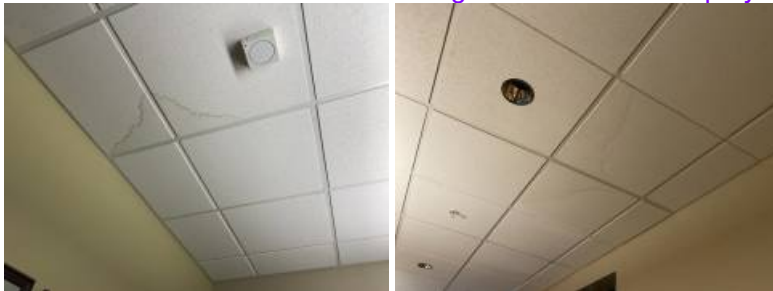
The majority of the ceilings are dropped down T-Bar type panels. Ceilings are in serviceable condition with the exception of the following: Moisture stains were noted in the conference room, middle office. I am unable to determine if active leakage exists. Make inquiry with the seller as to the history of leaks.
