Property Inspection Report

1234 Anywheretown

City Place, CA 12345

June 5, 2020

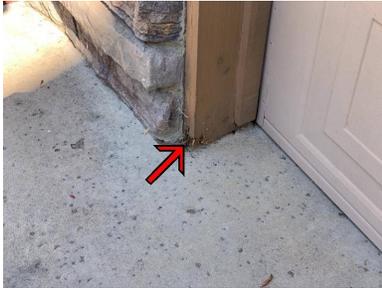
General condition of flashing and trim appears serviceable. As a preventative maintenance measure we recommend caulking/sealing all voids at siding joints, common trim, and around windows and doors to avoid the possibility of water intrusion and damage. All wood materials should be kept painted to avoid the possibility of moisture related deterioration. **Exposed wood and worn paint surfaces at various locations of the house need painting to help prevent deterioration. Deterioration was noted to the trim at various locations of the house. A qualified trim contractor should be called to make repairs to the damaged areas. Also refer to pest inspection report for repair recommendations.**

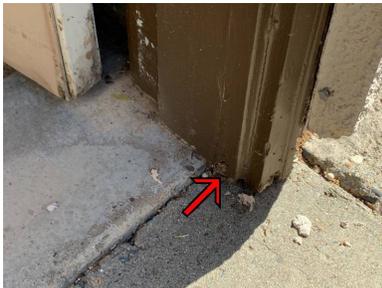
Exterior Doors:

Side garage door. Appears serviceable. Hardware operational. **Deterioration noted to door jamb. A qualified trim carpenter should be called to make repairs as needed. Also refer to your pest inspection report for repair recommendations.**

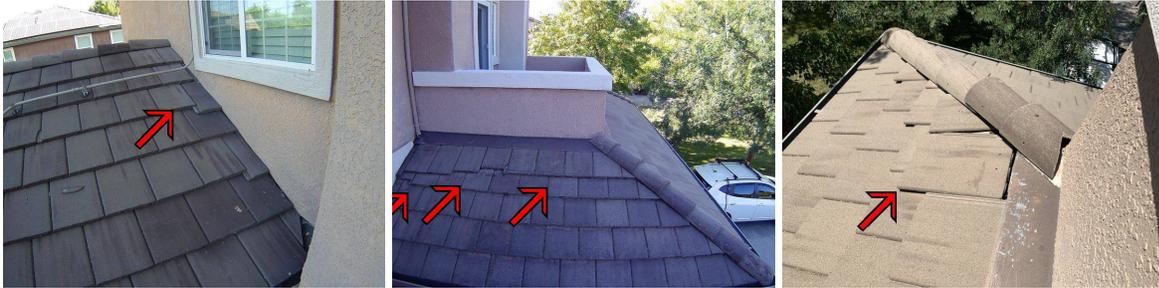
Type: Concrete tile. The typical life for a tile roof is approximately 50yrs. General condition appears serviceable at the time of the inspection. **REGULAR MAINTENANCE RECOMMENDED:** This usually consists of repair/replacement of cracked or loose tiles. This maintenance should help insure the weather tightness of the building and should be performed on a regular basis. **Moss growth was noted on roof surface. Removal is recommended. Some areas of the roof surface were obstructed by solar panels and not inspected. Corner cracks noted in various areas of the roof. Make repairs as needed at next roof service. Cracked and slipped tiles noted in various locations of the roof. The underlayment is exposed. A licensed roofing contractor should be called to make repairs as needed.**

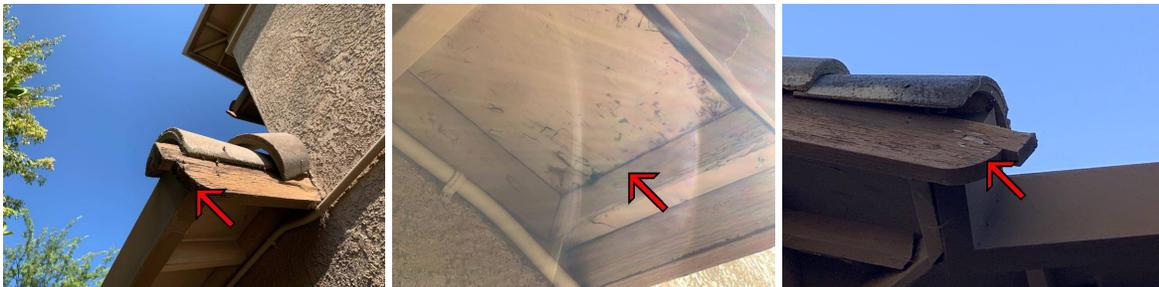
4.6 Type & Condition:

General condition of the overhangs appear serviceable. As a preventative maintenance measure we recommend overhangs be kept painted to avoid the possibility of premature deterioration. Seal any openings to prevent rodent entry into the home/attic. **Worn paint noted to some areas of the overhangs. Paint these areas to prevent premature deterioration. Deterioration noted to barge rafters at various locations. Deterioration noted to overhangs at various locations. A qualified trim carpenter/contractor should be called to make repairs as needed. Also refer to pest inspection report for repair recommendations.**

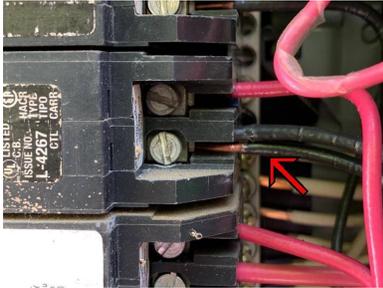
Main electrical panel appeared to be in serviceable condition at the time of the inspection. Panel appeared to be properly labeled. **Double tapping not allowed - There are multiple wires connected to a single breaker where only one wire should be connected. Have a licensed electrician make corrections as needed.**

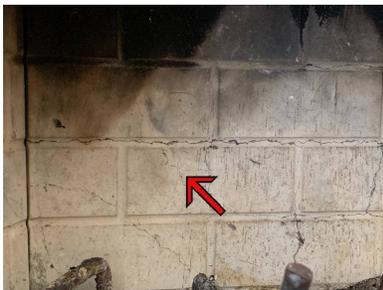
Type: Gas/Wood - The fireplace is designed to use gas fuel and/or burn wood. Damper is operational. Appears serviceable. **Damper door is operational but had no stop on the door. A damper stop is recommend in gas fireplaces to allow unburned gases to exit the fireplace. Correction recommended. Recommend chimney cleaning & certification prior to use to remove creosote deposits and other debris from chimneys and vents. Any cracking should be evaluated before use. The burner is mounted improperly and needs to be re-secured. Firebox interior panel is damaged and needs evaluation or repair before use.**

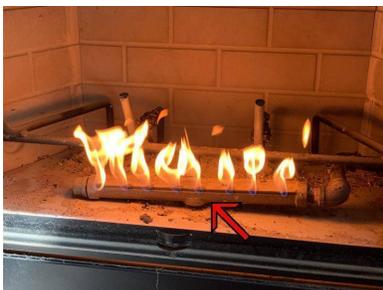
6.11 Living Room Fireplace:

Type: Gas/Wood - The fireplace is designed to use gas fuel and/or burn wood. Damper is operational. Appears serviceable. **Damper door is operational but had no stop on the door. A damper stop is recommend in gas fireplaces to allow unburned gases to exit the fireplace. Correction recommended. The burner is mounted improperly and allows flames to exit the fire box when turn on. Re-securing is needed.**

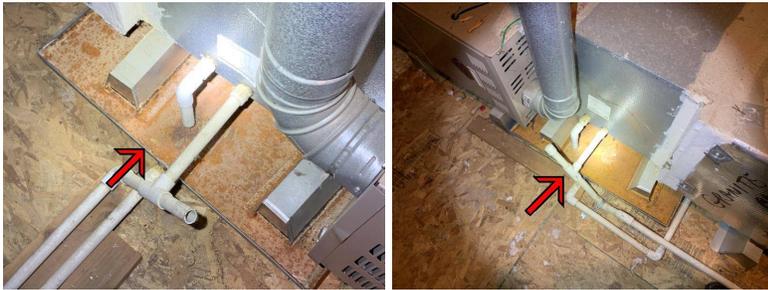
Primary and secondary condensate lines installed, Appears serviceable as far as visible. **Condensation stains and rusting noted in drip pan from a previous leak. Further evaluation is recommended by a licensed HVAC technician to determine the condition of condensate line and pan.**

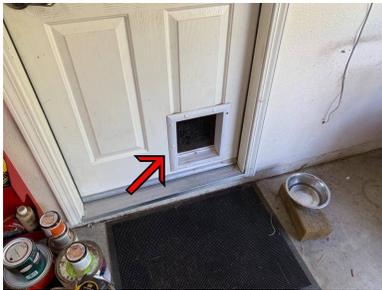
There is a fire rated or solid core door separating the garage from the living areas of the house. The door had self-closing hinges installed and operable and appeared to be in serviceable condition at the time of the inspection. **Left door threshold sags under foot pressure and is loose. Support is recommended to prevent damage. There is a pet door opening in the left fire door. The fire rating of this door is compromised. Repair or replacement is needed to restore its fire rating.**

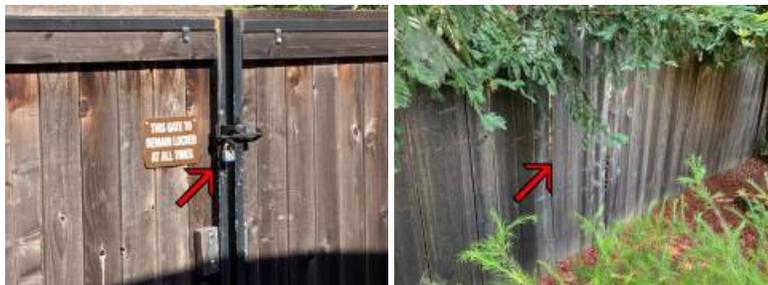
2.7 Condition:	<input type="checkbox"/>	<input checked="" type="checkbox"/>	<input type="checkbox"/>	Type: Wood. General condition of fence and gate appears serviceable. Typical maintenance recommended: This includes making repairs/adjustments to gates, repair or replacement of loose/rotted posts and repair or replacement of damaged/missing boards. Damaged fence boards noted. Replace as needed. Some fencing was inaccessible due to vegetation or stored items. Inaccessible fencing could not be fully inspected. Fence is worn with some damage noted consistent with its age. Some minor repairs or adjustments are needed. Loose sections are noted in some locations. Make repairs as needed. Gate locked at time of inspection. Gate needs repair or adjustment.
----------------	--------------------------	-------------------------------------	--------------------------	--

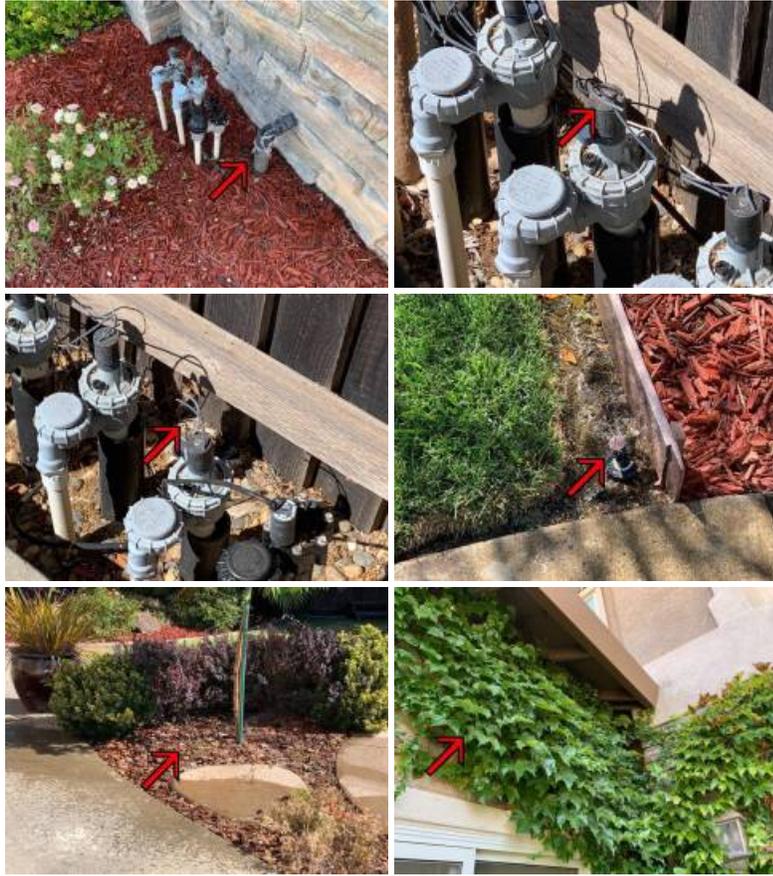
NOTE: Low voltage lighting systems, underground drains, fountains and ponds are beyond the scope of this inspection and are not inspected. General condition of landscaping appears serviceable at the time of the inspection. Sprinklers were operated manually using the bleed valve. Each zone is tested for proper operation of valves and heads. Minor leaks, chipped heads and adequacy of coverage is not noted in the report. Below ground sprinkler and drip pipe leaks will be reported only if evident at the time of the inspection. **Typical Maintenance Recommended:** This includes making repair/adjustments to sprinklers and drips. **Keep plants trimmed away from structure. Foliage is in contact with the walls in various locations. Trim foliage away from walls as needed to prevent damage. Some disconnected irrigation valves were noted. Sprinkler heads in some areas are damaged or non functional. Further evaluation and repairs are recommended. Unknown piping noted at the front of the house. Inquire with the seller regarding its use. Loose drip line at the back of the house. Repair is recommended.**

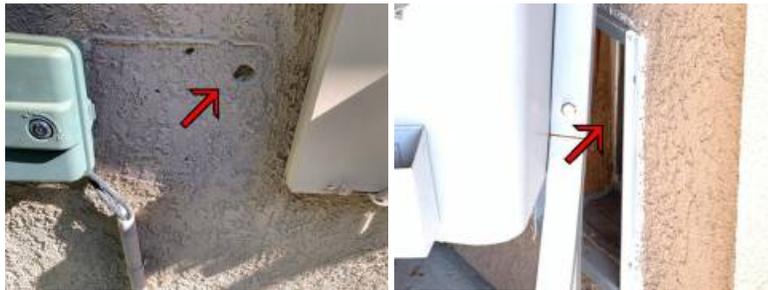
- 3.1 *Materials & Condition:* OK MM RR
 Walls are constructed with Stucco. General condition appears serviceable. Cracks noted are typical. Monitor for future movement. As a preventative maintenance measure we recommend caulking/sealing all cracks 1/16" or larger to avoid the possibility of water intrusion. **Note: Some areas of the exterior were inaccessible due to vegetation or stored items. Inaccessible areas were not inspected. Stucco repairs needed in various areas of the house. Dog door opening noted at the back of the house. Repair opening if not needed.**

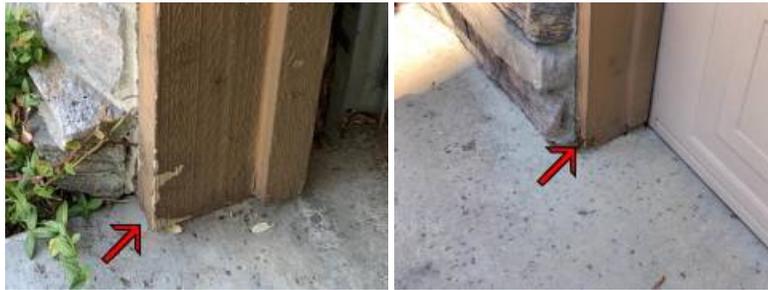
- 3.2 *Flashing & Trim:* General condition of flashing and trim appears serviceable. As a preventative maintenance measure we recommend caulking/sealing all voids at siding joints, common trim, and around windows and doors to avoid the possibility of water intrusion and damage. All wood materials should be kept painted to avoid the possibility of moisture related deterioration. **Exposed wood and worn paint surfaces at various locations of the house need painting to help prevent deterioration. Deterioration was noted to the trim at various locations of the house. A qualified trim contractor should be called to make repairs to the damaged areas. Also refer to pest inspection report for repair recommendations.**

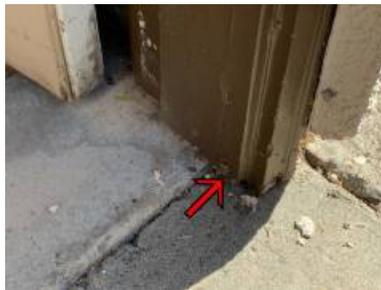
<input type="checkbox"/>	<input type="checkbox"/>	<input checked="" type="checkbox"/>	Side garage door. Appears serviceable. Hardware operational. Deterioration noted to door jamb. A qualified trim carpenter should be called to make repairs as needed. Also refer to your pest inspection report for repair recommendations.
--------------------------	--------------------------	-------------------------------------	--

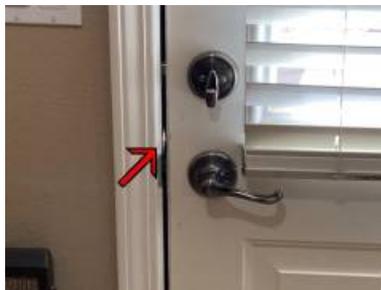
3.6 Rear Entry Door:

<input type="checkbox"/>	<input checked="" type="checkbox"/>	<input type="checkbox"/>	Appears serviceable. Hardware operational. Make improvement to weather stripping.
--------------------------	-------------------------------------	--------------------------	--

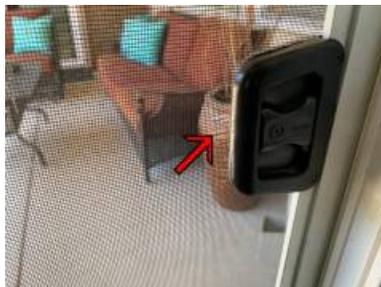
3.7 Rear Slider:

<input type="checkbox"/>	<input checked="" type="checkbox"/>	<input type="checkbox"/>	Sliding glass. Appears serviceable. Hardware operational. A screen door is present and was in generally serviceable condition. The screen door material is damaged and needs repair or replacement.
--------------------------	-------------------------------------	--------------------------	--

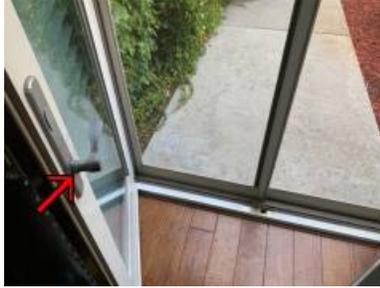
| 3.9 Front Office Door: | <input type="checkbox"/> | <input checked="" type="checkbox"/> | <input type="checkbox"/> | Appears serviceable. Hardware operational. Deadbolt wont latch without the handing being lifted. This may be by design but is not typical. Further evaluation and repair is recommended. The screen door is tight to operate and needs adjustment or repair to function properly. |

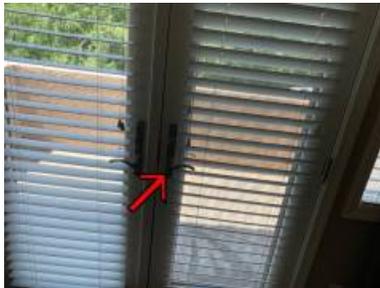
| 3.12 Front Balcony Door: | <input type="checkbox"/> | <input checked="" type="checkbox"/> | <input type="checkbox"/> | Appears serviceable. Hardware operational. Deadbolt wont latch without the handing being lifted. This may be by design but is not typical. Further evaluation and repair is recommended. |

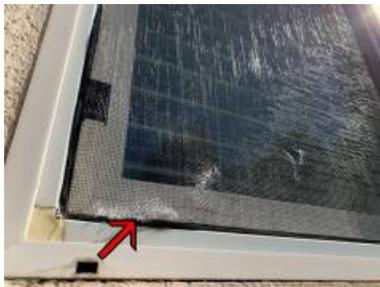
| 3.14 Overall Condition: | <input type="checkbox"/> | <input checked="" type="checkbox"/> | <input type="checkbox"/> | Satisfactory overall, considering age. Some screens are in fair condition, with fading or small holes noted. Some screens are missing. Replace as needed. |

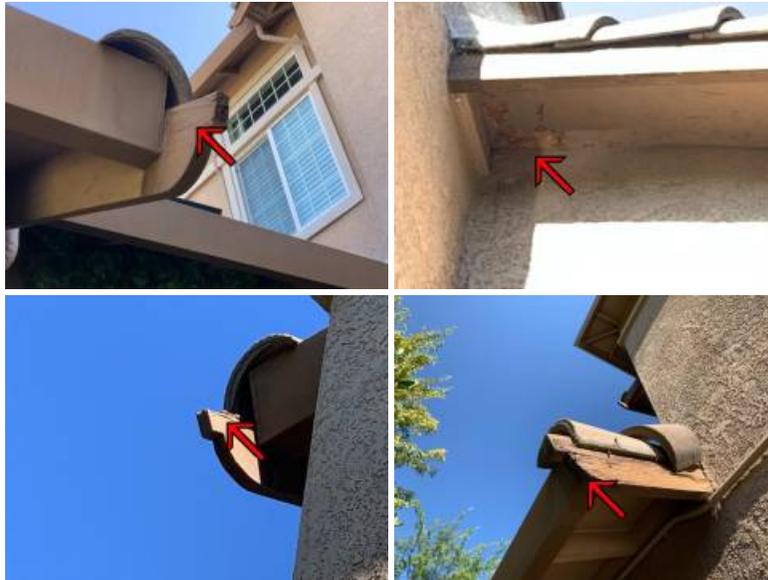
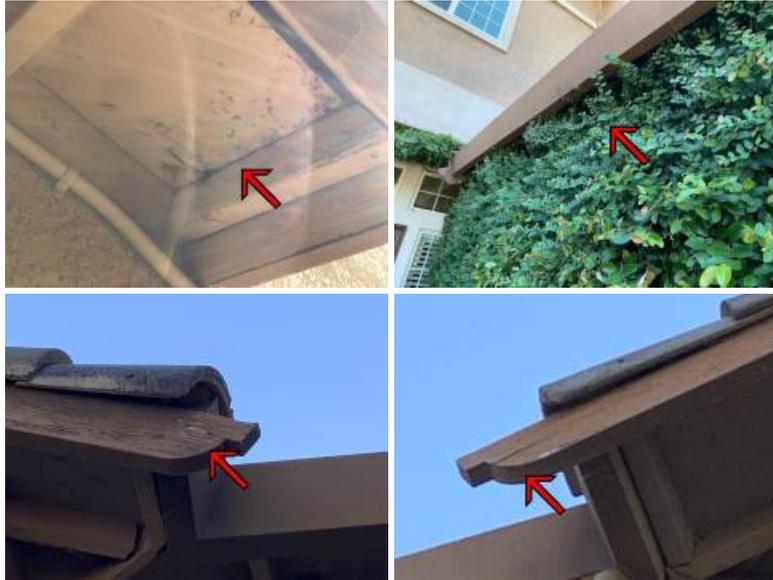
4.6 Type & Condition:

General condition of the overhangs appear serviceable. As a preventative maintenance measure we recommend overhangs be kept painted to avoid the possibility of premature deterioration. Seal any openings to prevent rodent entry into the home/attic. **Worn paint noted to some areas of the overhangs. Paint these areas to prevent premature deterioration. Deterioration noted to barge rafters at various locations. Deterioration noted to overhangs at various locations. A qualified trim carpenter/contractor should be called to make repairs as needed. Also refer to pest inspection report for repair recommendations.**

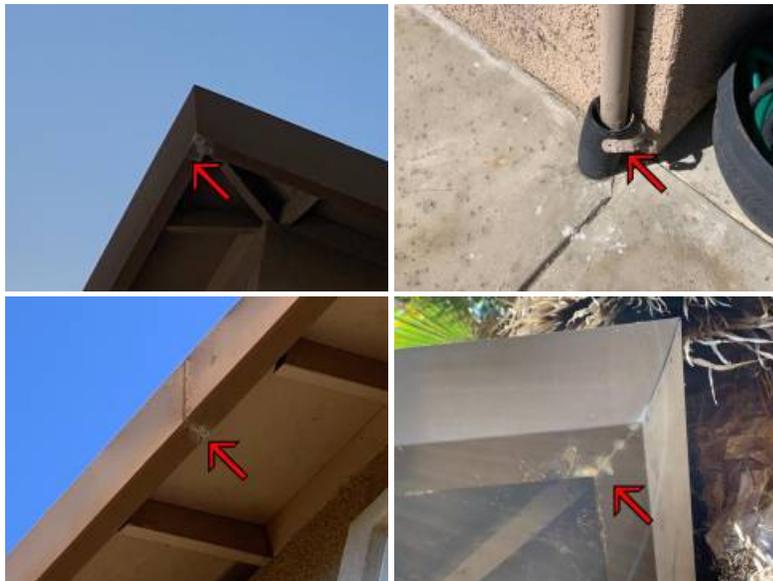
4.7 Type & Condition:

General condition of the gutters and downspouts appear serviceable. Periodic cleaning recommended. **Debris in gutters, evidence of leakage at seams. Cleaning and sealing recommended.**

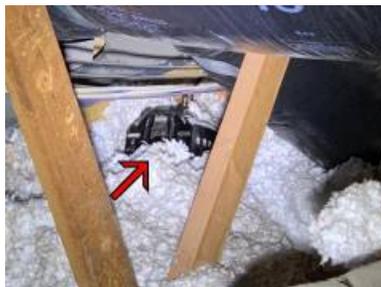
4.8 Access And Observations: OK MM RR Attic was accessible at the time of the inspection. The inspector was unable to view some areas of the attic due to ductwork and/or low head clearance. Note: The presence of rodents in the attic is beyond the scope of this inspection. The inspector may report of any visible evidence. **An abandoned motor was noted next to the whole house fan. Removal is recommended.**

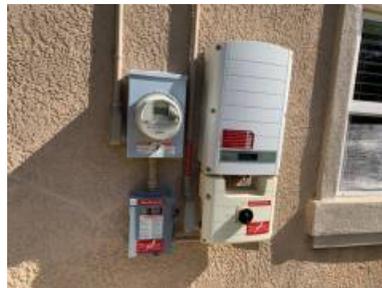
5.1 Type & Condition:

Underground, 110/220 Volt, Circuit breakers. General condition appears serviceable. **Solar system not inspected. Inquire with seller.**

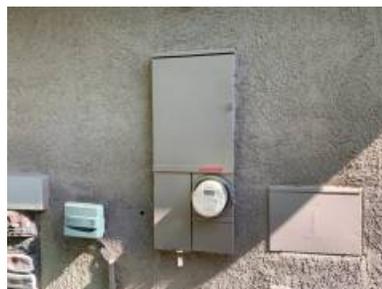
5.3 Main Panel Location:

The main electrical service panel was located at the right side of the residence exterior.

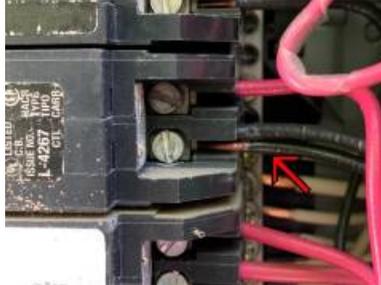
tapping not allowed - There are multiple wires connected to a single breaker where only one wire should be connected. Have a licensed electrician make corrections as needed.

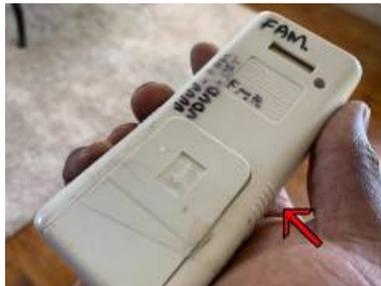
General condition of the switches and fixtures throughout the house are in serviceable condition. **Lights are not operational in some areas, possibly due to bad bulbs, ballasts or switches. Replace defective bulbs and test fixtures for proper operation and make repairs if needed. The ceiling fan installed in the family room wobbles and needs balancing/adjustment or repair. This fan remote is damaged and needs repair.**

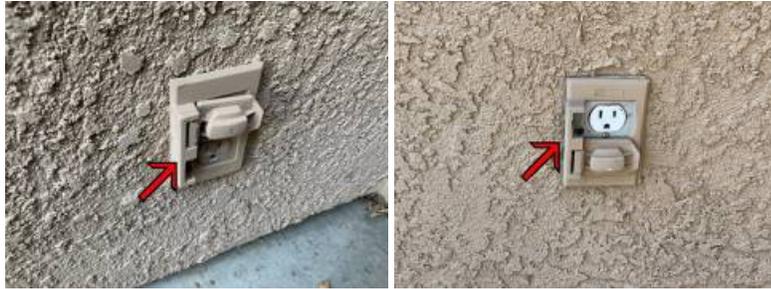
Exterior electrical outlets were Ground Fault Circuit Interrupter (GFCI)-protected, enclosed in weather-resistant covers, responded to testing and appeared to be in serviceable condition at the time of the inspection. Light fixtures appeared to be in generally serviceable condition. Some lights are not operational, possibly due to bad bulbs. Replace burnt bulbs and test fixtures for proper operation. **Some outlet covers at the exterior are damaged and need replacement.**

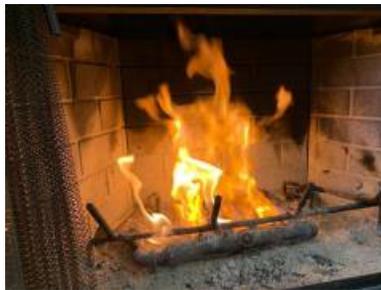
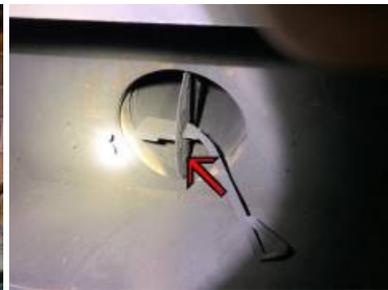
Type: Gas/Wood - The fireplace is designed to use gas fuel and/or burn wood. Damper is operational. Appears serviceable. **Damper door is operational but had no stop on the door. A damper stop is recommend in gas fireplaces to allow unburned gases to exit the fireplace. Correction recommended. Recommend chimney cleaning & certification prior to use to remove creosote deposits and other debris from chimneys and vents. Any cracking should be evaluated before use. The burner is mounted improperly and needs to be re-secured. Firebox interior panel is damaged and needs evaluation or repair before use.**

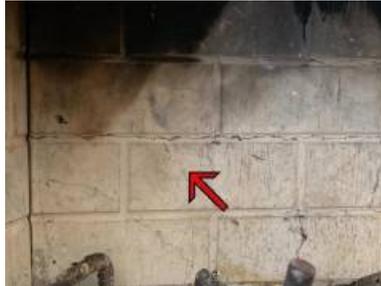
6.11 Living Room Fireplace:

Type: Gas/Wood - The fireplace is designed to use gas fuel and/or burn wood. Damper is operational. Appears serviceable. **Damper door is operational but had no stop on the door. A damper stop is recommend in gas fireplaces to allow unburned gases to exit the fireplace. Correction recommended. The burner is mounted improperly and allows flames to exit the fire box when turn on. Re-securing is needed.**

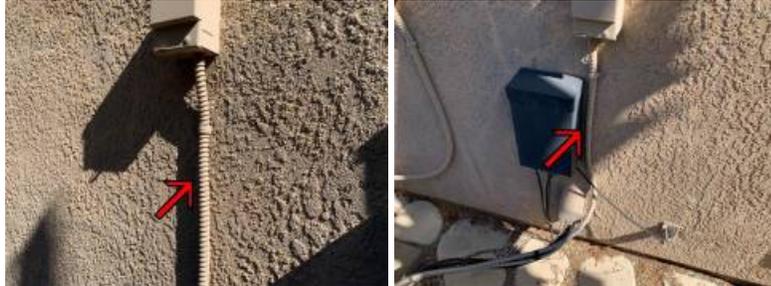
Electric - 220 Volt. Electrical disconnect present, **Water tight conduit recommended between the disconnect box and the condenser unit.**

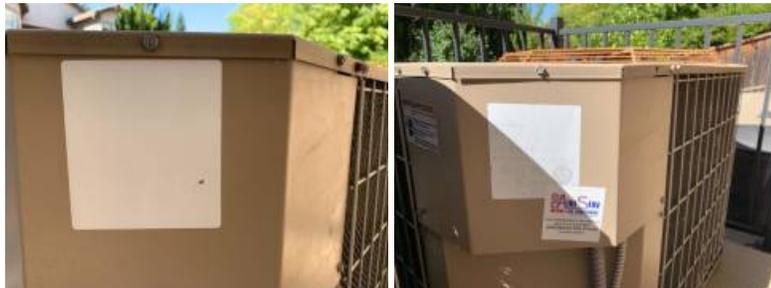
6.15 Capacity / Approx. Age:

Data plate was illegible and this is an educated guess as to its correct size, 10+ SEER. Approx. 18 years. The typical service life for a air conditioning unit is 16 - 20 years. **Although operational at the time of the inspection, the age of this unit is such that you may need to replace it in the near future.**

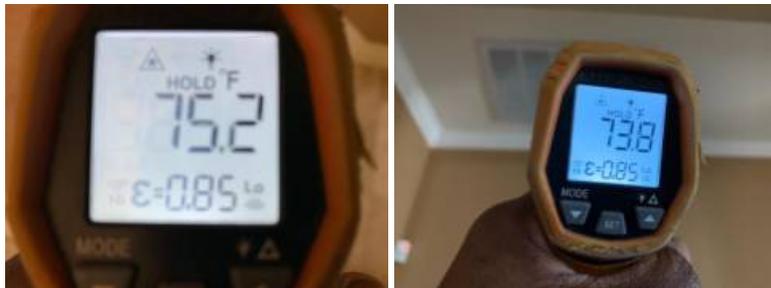
6.16 Return Air Temp:

Approx. 75 F. Downstairs.
 Approx, 74 F Upstairs.

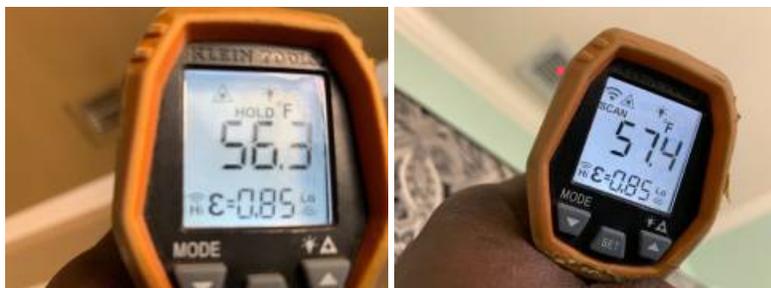
6.17 Supply Air Temp:

Approx, 56 F. Downstairs.
 Approx, 57 F. Upstairs.

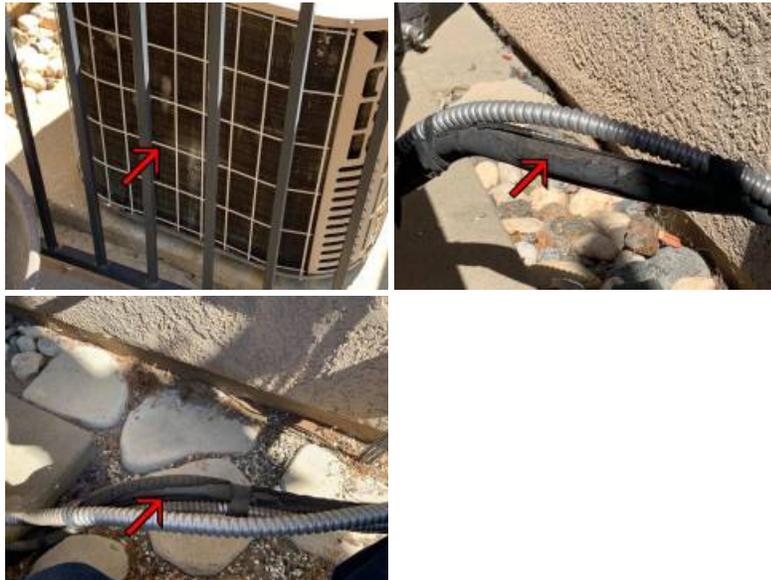
6.19 System Condition:

General condition appears serviceable. The unit did produce an adequate temperature drop during limited test run. Annual servicing recommended. **The upstairs unit temperature drop was marginal. The unit appears to need servicing. A licensed HVAC contractor should be called to make further evaluation and repairs as needed. The condenser fins are bent in various locations. Have your AC technician make correction recommendations. Refrigerant suction line is exposed and needs pipe insulation added at a minimal expense.**

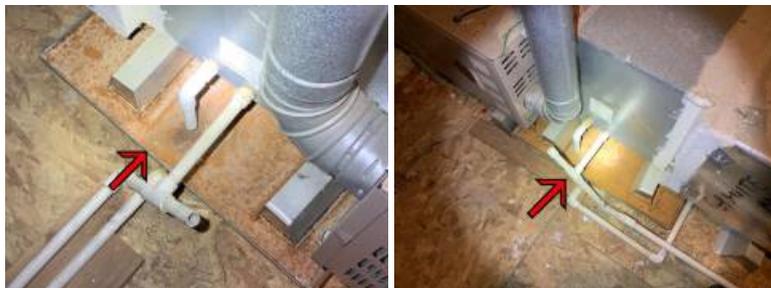
6.20 Condensate Line:

Primary and secondary condensate lines installed, Appears serviceable as far as visible. **Condensation stains and rusting noted in drip pan from a previous leak. Further evaluation is recommended by a licensed HVAC technician to determine the condition of condensate line and pan.**

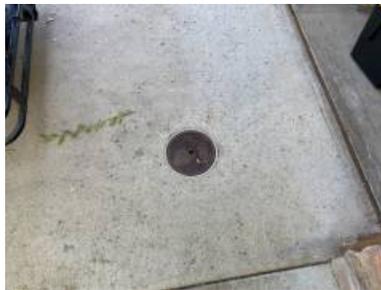
7.7 Condition:

Lines not fully visible. Visible lines, traps and vents appear serviceable. No problems noted at the time of the inspection, but monitor in the future. Main waste cleanout is at the front.

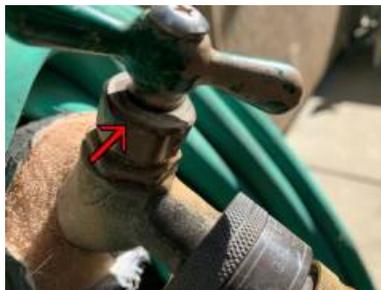
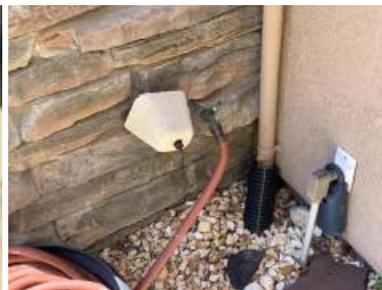
Exterior hose bibbs appeared to be in serviceable condition at the time of the inspection. **Hose bibbs at various locations of the house leak at the stem when operated. Recommend repair or replacement. Hose bibbs at the side of the garage for unknown use. Verify use with the seller.**

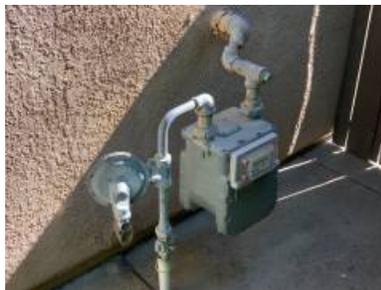
| 7.13 Meter / Tank: | <input checked="" type="checkbox"/> | <input type="checkbox"/> | <input type="checkbox"/> | Public - Natural gas. Meter located at the right of the residence exterior. System appears serviceable. |

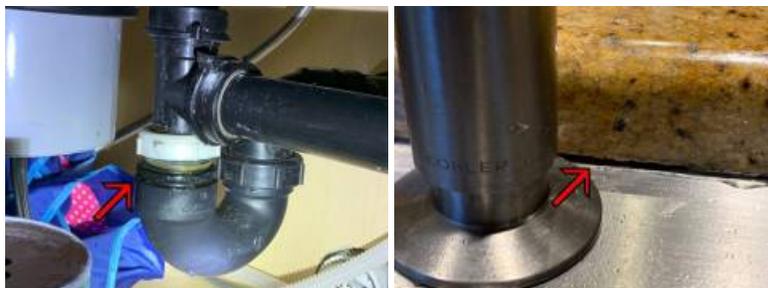
| 7.14 Kitchen Sink: | <input type="checkbox"/> | <input checked="" type="checkbox"/> | <input type="checkbox"/> | Stored items prevent access and full viewing under the sink. The kitchen sink, faucet and drainage appeared to be in serviceable condition at the time of the inspection. Staining/weathering was noted below the sink. No evidence of current leaks but monitor in the future. Openings noted around plumbing pipe penetrations through wall. Recommend sealing openings around pipes with approved materials. Encrustation was noted to drainage piping indicating previous leakage. Monitor for leakage in the future. Sealant recommended between the sink and the countertop to prevent water leakage. |

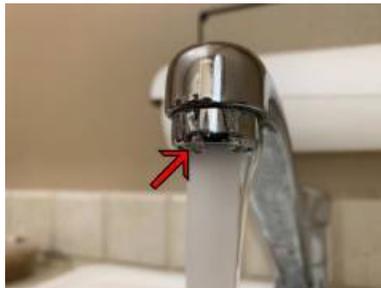
Stored items prevent full inspection, General condition of sink and faucet appears serviceable. Drainage is proper. **The aerator leaks and needs repair.**

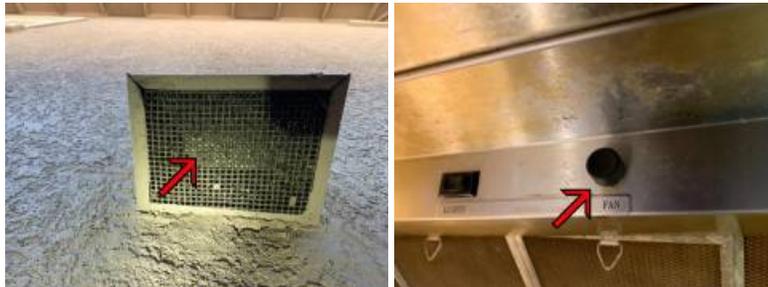
| | <input type="checkbox"/> | <input checked="" type="checkbox"/> | <input type="checkbox"/> | External. Fan/Hood operational, Grease screen is dirty and needs cleaning for proper airflow. The fan switch knob is loose and needs repair or replacement. |

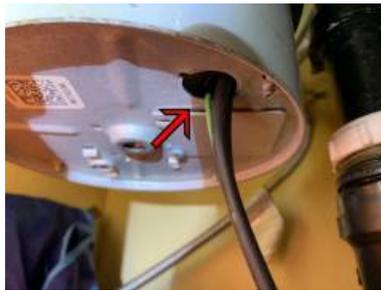
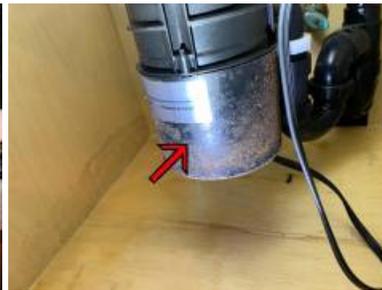
The garbage disposal operated properly at the time of the inspection. **Improper wiring noted - There was NO strain relief installed on the main disposal electrical supply cable. Correction recommended. Rusting noted on the outer casing of the island garbage disposal. Monitor for leakage in the future.**

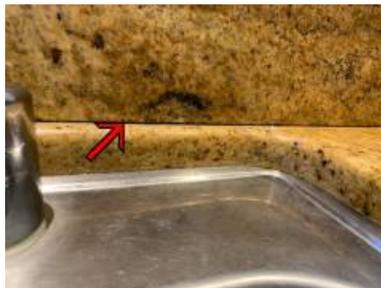
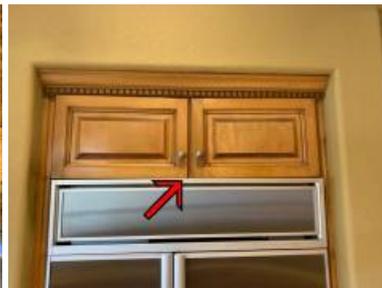
Stored items prevent full inspection of the cabinets, The kitchen counters and cabinets appeared to be in generally serviceable condition at the time of the inspection. Normal wear noted. Keep vicinity of the sink caulked/sealed to prevent water intrusion. **Cabinet door hardware needs minor adjustment or repair. Grout is cracked at back splash. Sealant recommended at counter top to back splash joint to prevent water leakage under the sink.**

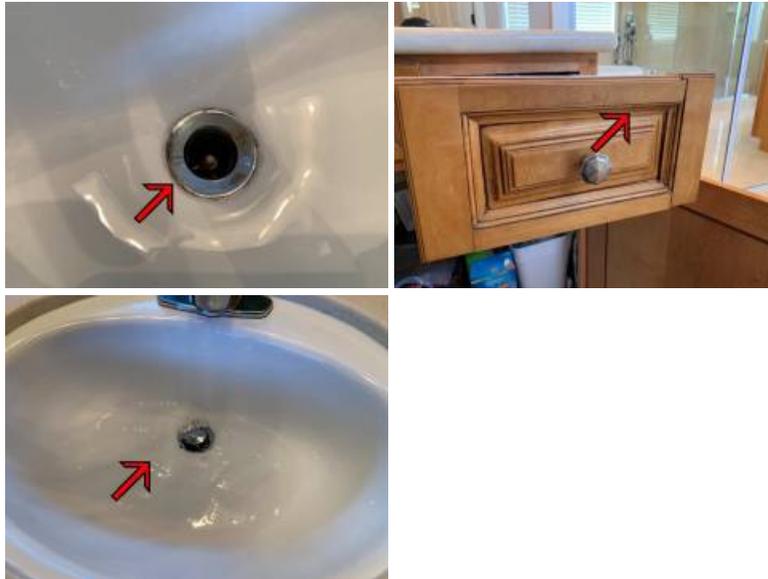
Stored items prevent access and full viewing under the sink. Sink, fixtures, drainage, counters and cabinets appeared to be in generally serviceable condition. **Sink drain stopper is nonfunctional and needs adjustment or replacement. The drain stop cap is missing. Make repairs as needed. Cabinets are worn and have staining and/or minor damage noted. Some repair may be needed. The sink drainage appeared a bit slower than normal. Drain appears to need cleaning.**

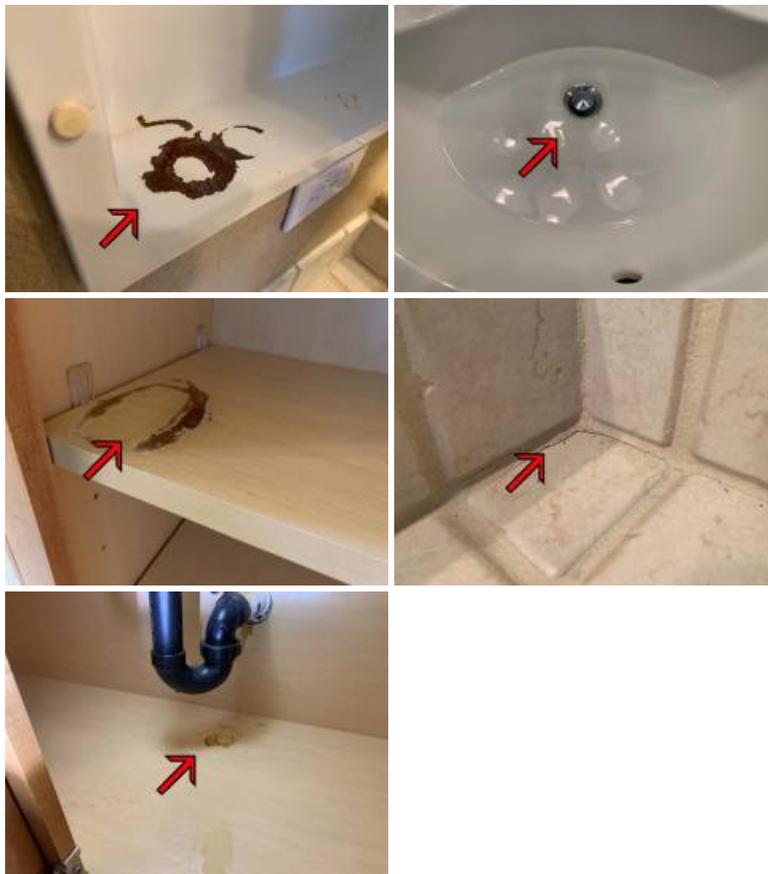
9.3 *Left Bathroom* Between OK MM RR
Bedrooms:

Stored items prevent access and full viewing under the sink. Sink, fixtures, drainage, counters and cabinets appeared to be in generally serviceable condition. **Staining/weathering noted below the sink. There are no signs of current leaks. Monitor in the future. Cracked grout noted in some areas of the counter. Sealant recommended at cracked areas. The sink drainage appeared a bit slower than normal. Drain appears to need cleaning. Cabinets are worn and have staining and/or minor damage noted. Some repair may be needed. Rusting and/or worn paint noted in medicine cabinet. Make repairs as needed.**

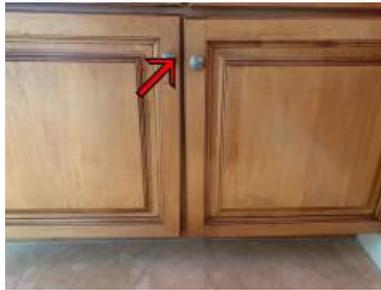
9.5 Downstairs Bedroom Bath:

Stored items prevent access and full viewing under the sink. Sink, fixtures, drainage, counters and cabinets appeared to be in generally serviceable condition. **The sink drainage appeared a bit slower than normal. Drain appears to need cleaning.**

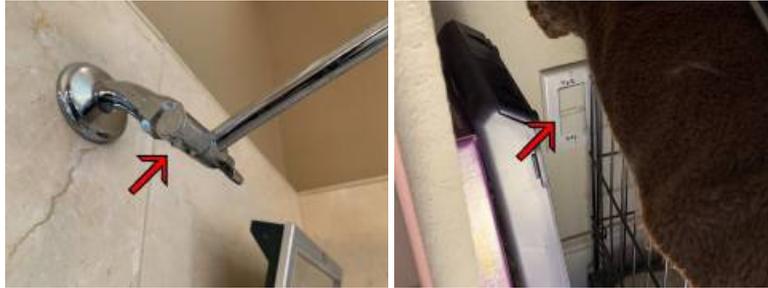
9.11 Master Bath:

The fixtures appeared to be in generally serviceable condition at the time of the inspection. The jacuzzi is functioning satisfactorily, has a proper equipment access door and GFCI protection installed. **Shower valve handle is loose and needs re-securing. Leakage was noted at the showerhead connection. Make repairs as needed.**

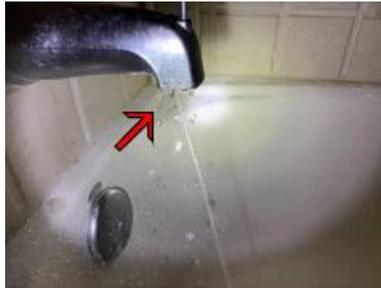
OK MM RR
 9.12 Front Bathroom Between The fixtures appeared to be in generally serviceable condition at the time of the inspection. **Hot and cold water is reversed at shower valve. Have a licensed plumber make corrections as needed. Shower valve handle is loose and needs re-securing. Shower diverter needs adjustment or replacement. Water continues to run through the tub spout when the diverter is in the shower position.**
 Beds:

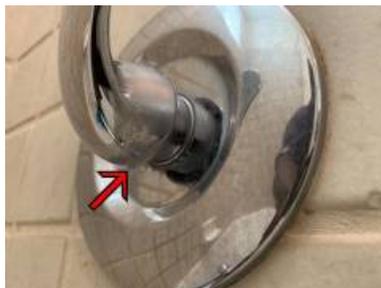
9.15 Downstairs Bedroom Bath: The fixtures appeared to be in generally serviceable condition at the time of the inspection. **Leakage was noted at the shower valve. Shower valve stem or cartridge appears to need replacement.**

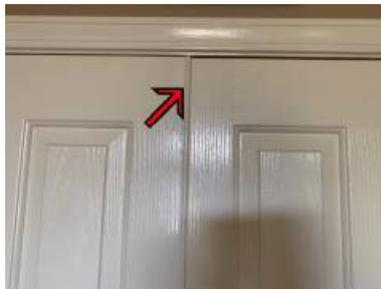
OK	MM	RR	
10.2	Overall	Interior	Door	<input type="checkbox"/>	<input checked="" type="checkbox"/>	<input type="checkbox"/>	Stored items or furnishings prevent full inspection of some doors. The doors throughout the home appeared to be in serviceable condition at the time of the inspection. Master bedroom doors rub together and need adjustment to function properly.
<i>Condition:</i>

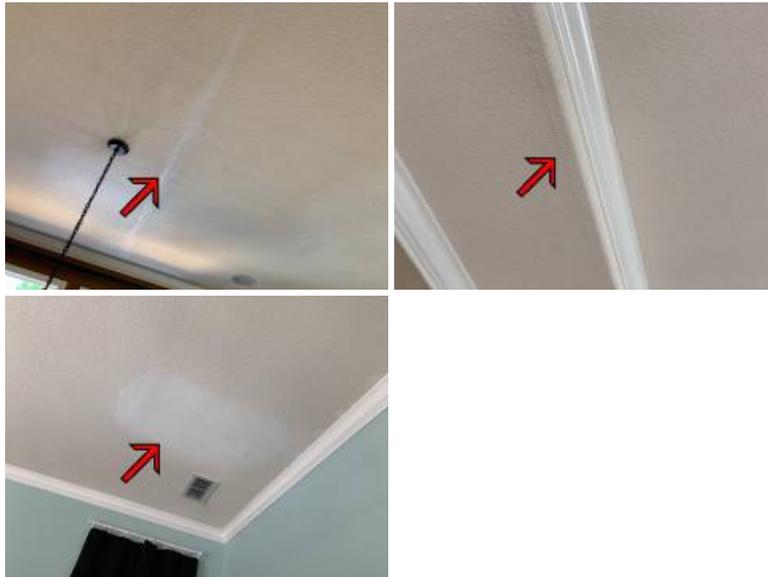
10.5 General Type & Condition: OK MM RR Drywall, Ceilings appeared to be in generally serviceable condition throughout the home at the time of the inspection. **There is some minor cracking noted. Be sure to take note of any future movement. Most minor cracking is due to shrinkage of the construction materials. Previous repair noted in some locations including the downstairs bedroom. Inquire with seller regarding previous repairs.**

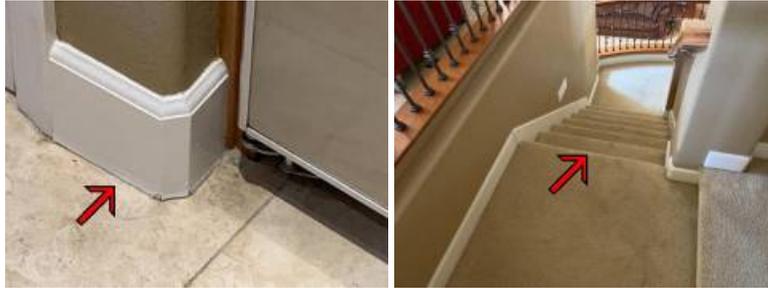
10.6 General: OK MM RR Stored items or furnishings prevent full inspection, The home floor surfaces appeared to be in generally serviceable condition at the time of the inspection. **The floors showed general wear in various areas. The floors in some areas exhibited minor squeaking at the time of the inspection. Moisture damage noted to the baseboards in some areas. Remove and replace damaged baseboards as needed.**

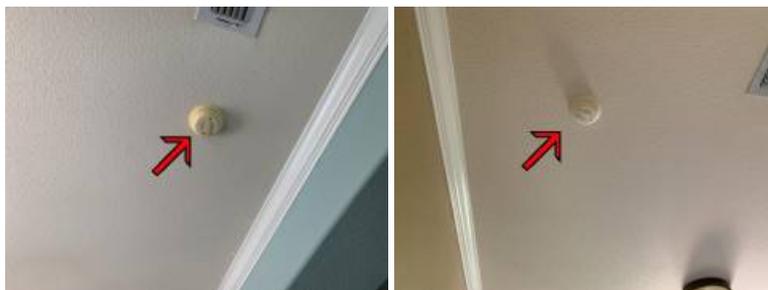
Note: Current standards recommend that smoke alarms be installed in all common hallways on each floor level and in all sleeping rooms. Carbon Monoxide detectors are recommended in common hallways on each floor level. Smoke alarms are hardwired and interconnected. Smoke alarms responded to test button operation. Carbon monoxide alarm(s) responded to test button operation. **Smoke alarms in some areas did not operate, possibly due to missing or dead batteries. Suggest changing batteries or replacement as needed. Older model alarms. Replacement should be considered.**

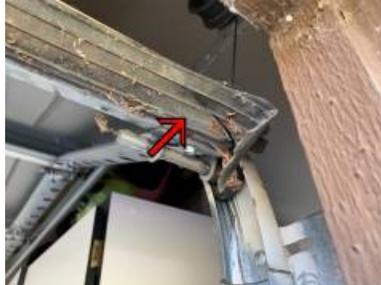
12.4 Material - Condition: Aluminum. The overhead vehicle door appeared to be in serviceable condition at the time of the inspection. **Suggest adding second door spring to protect door from damage in case single spring fails. Garage door rubber weather strip at the bottom is damaged or too short and proper seal is not being achieved. Repair or replacement is recommended.**

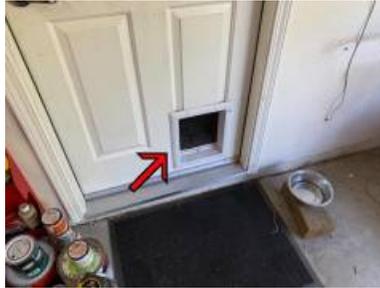
12.6 Service Doors: There is a fire rated or solid core door separating the garage from the living areas of the house. The door had self-closing hinges installed and operable and appeared to be in serviceable condition at the time of the inspection. **Left door threshold sags under foot pressure and is loose. Support is recommended to prevent damage. There is a pet door opening in the left fire door. The fire rating of this door is compromised. Repair or replacement is needed to restore its fire rating.**

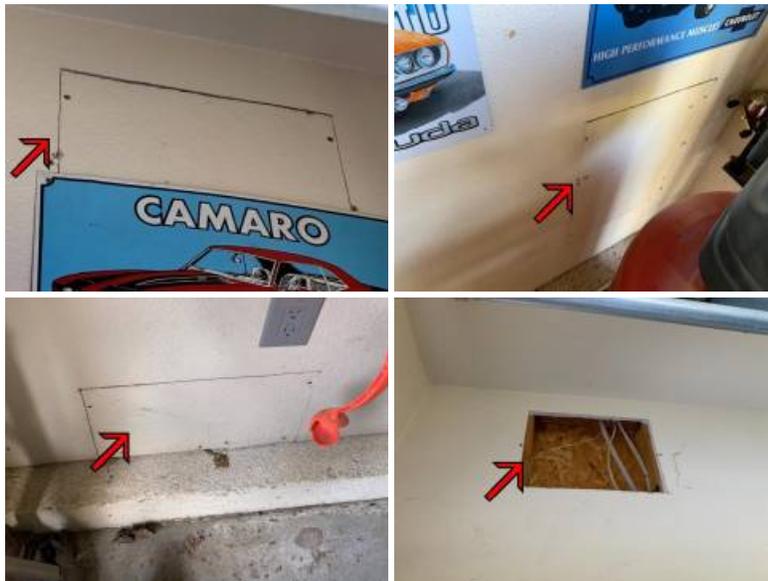
12.8 Type & Condition:

Stored items prevent full inspection, Drywall. The garage walls appeared to be in serviceable condition at the time of the inspection.
Wall damage noted in various areas. Repair as needed.

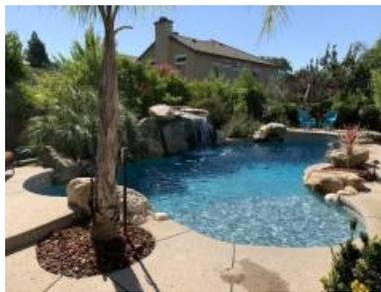
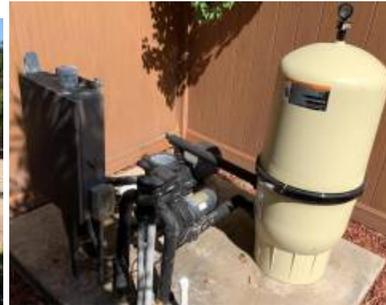
13.0

OK MM RR
 Good overall condition.

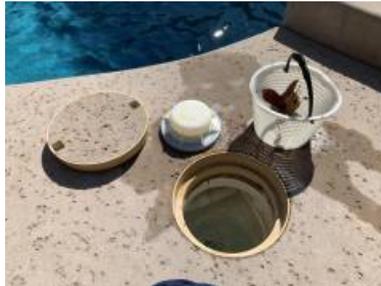
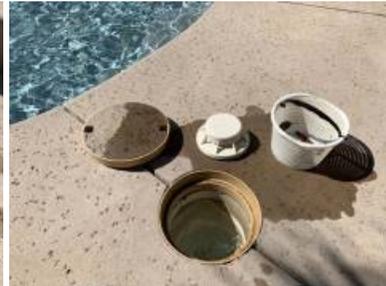
13.2 Condition:

Appears serviceable with good skimming action. A float valve was installed.

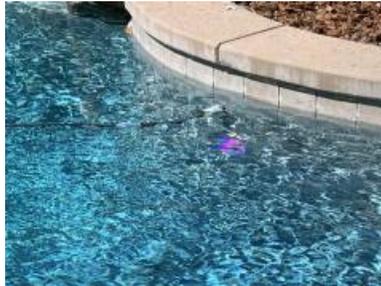
13.5

An LED pool light is installed. GFCI protection was functional during the inspection.

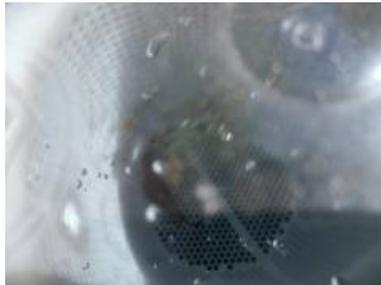
13.6 Filter Pump:

A variable speed pump is installed. The conduit connections are serviceable with little to no damage or wear noted. The motor is grounded and bonded. **The debris basket needed cleaning at the time of the inspection. The debris basket lid was not removed during the inspection. The pump housing has no securing screws or bolts noted. Securing is recommended.**

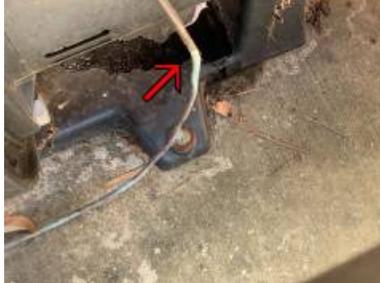
13.8 Evidence Of Water Leakage: OK MM RR **One minor leak was noted near the pool cleaner pump. Make repairs as needed.**

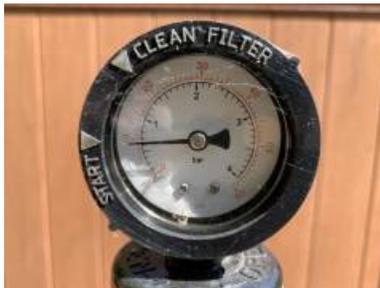
13.9 Pool Filter: A Cartridge filter is installed. General condition appears serviceable. The filter pressure was within normal operating range indicating the filter was not in need of cleaning during the inspection. **The filter was not disassembled during the inspection.**
